November 21, 2011

Thank you for giving Metro Inspections the opportunity to inspect your real estate investment. I hope that my inspection findings provide you with clear and concise information associated with the property located at 8221 Grand Ave, Austin, TX 78668.

Commercial Inspection of Property located at 8221 Grand Avenue, Austin, TX 78668

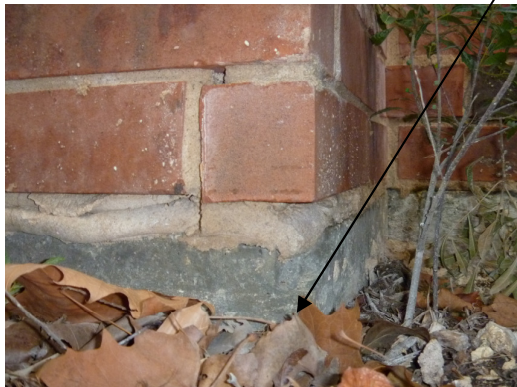
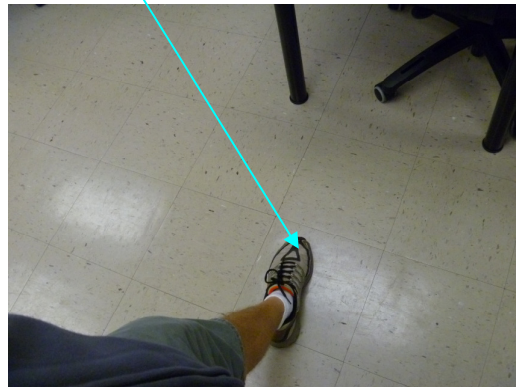
- Foundation-The slab foundation appears to be performing adequately at present time, however, there are raised areas and dips noted in center section of all 4 units. From a visual inspection, it appears to be repairs/rough installation of plumbing line tunnels from final floor layout, but the final repairs did not provide for a level floor. Recommend structural engineer review contractor blueprints and rough in tunnels to determine if any structural integrity was compromised.
- Slab edge has some rough areas and does not appear to have a parge coat applied around perimeter. Unable to determine if post tension cables were used.

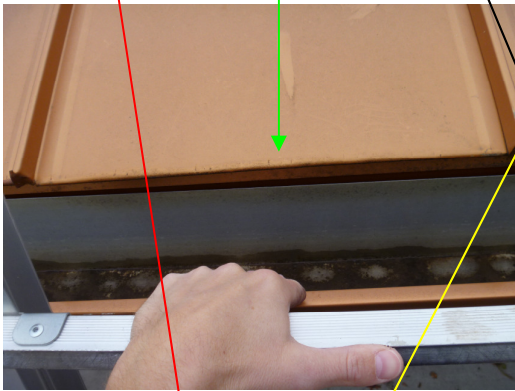
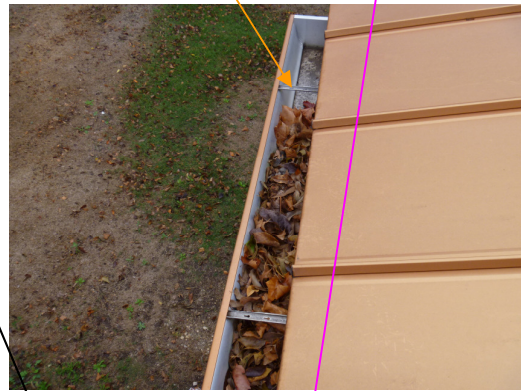
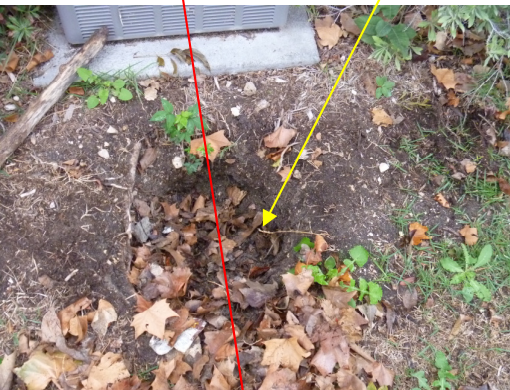
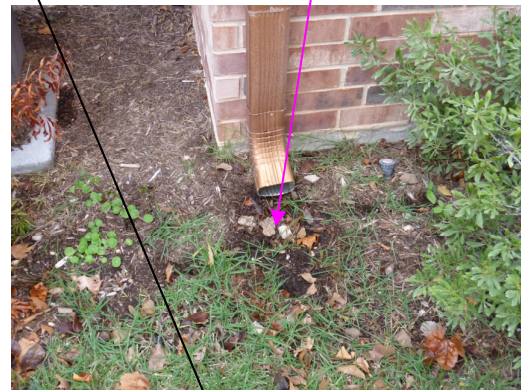
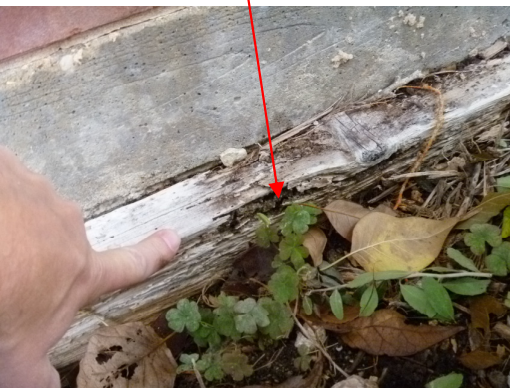
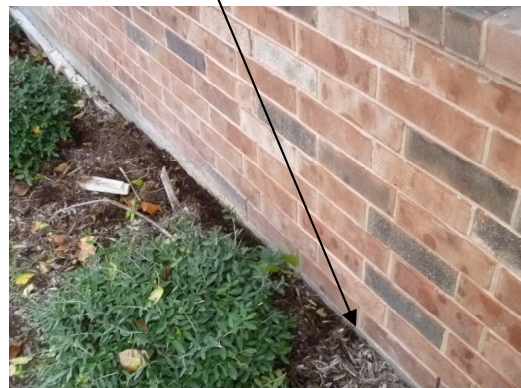
- Roof mounted gutters have loose areas that need to be secured with brackets and some sections are holding leaves/debris and standing water that needs removal. Adding splash block at back downspout will help with erosion control.
- Drainage appears to be negative towards the building at the South side (Ramble Creek street). In addition, there are some soft pockets a few feet from the building on South side (1 pocket will allow water ponding and needs backfill). Monitor drainage/runoff after rains to ensure water does not pond around slab.
- Soil/mulch line is too high at back and right side locations-needs to have slab to brick joint exposed.
- Also noted slab form boards left in place that need removal as there are live termites attacking wood. Recommend termite treatment as needed by professional applicator.

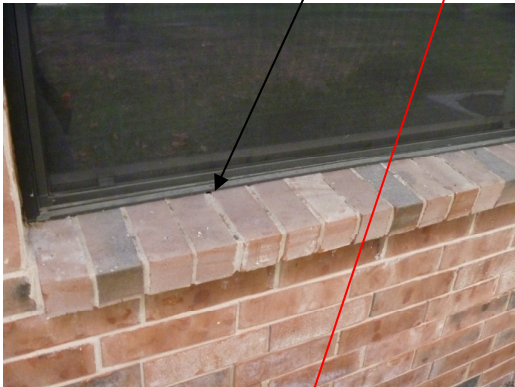
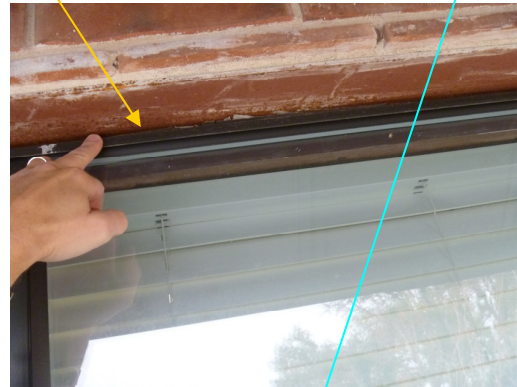
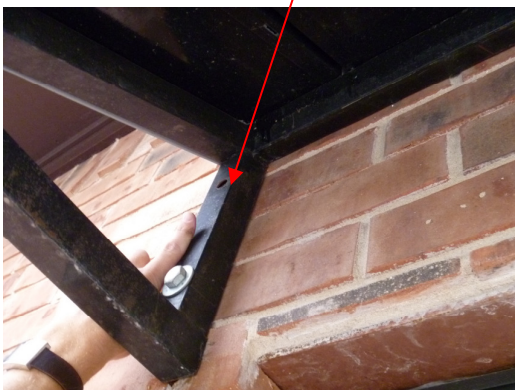
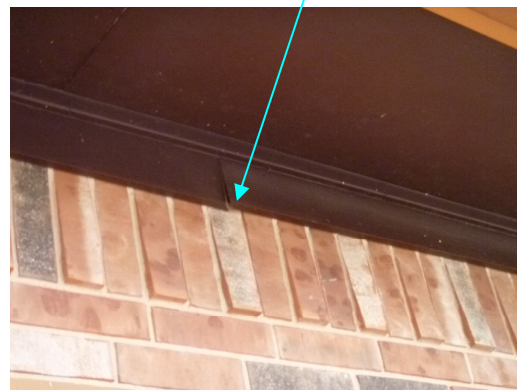
- Units 202 & 203 have missing twist knobs on deadbolt locks. Most front entry doors have damaged/deteriorated threshold sweeps.
- Unit 200 has missing hinge screws on back office door.
- Unit 201 has a binding/damaged jamb on back office door and bathroom door wont stay in set position. Also noted cracked window at back office.
- General caulking needed around window frames, brick frieze, joints, etc. Large gaps noted around window frames at East end.
- Metal awning on East side has only 1 bolt securing left frame rail. Loose fascia trim noted above front of unit 200.

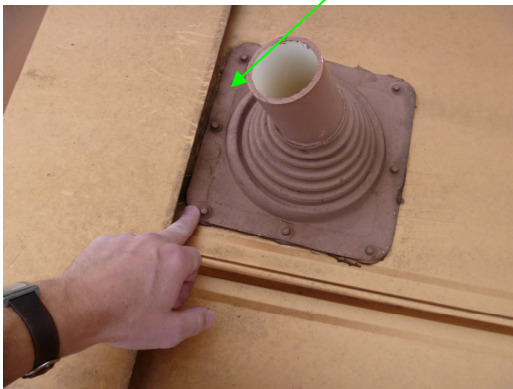
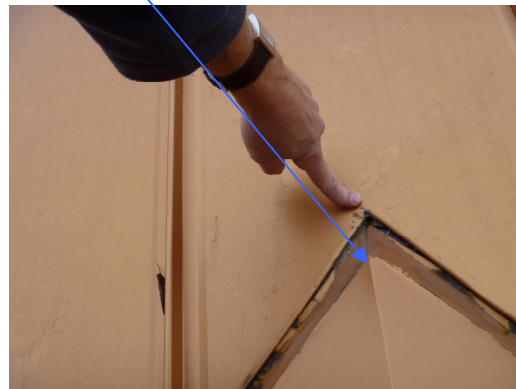
- Roof appears to be in good condition with no current leaks noted in attic. A few joints on roof surface need to be caulked.
- Fire blocking/separation divider was noted in attics.

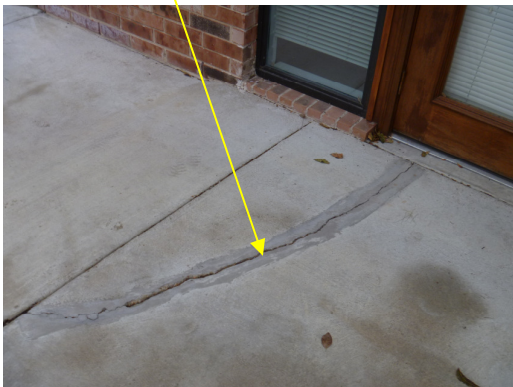
- Cracking/settling noted on sidewalk at unit 203 entry.
- No fire extinguishers were noted at the exterior common area for quick access.

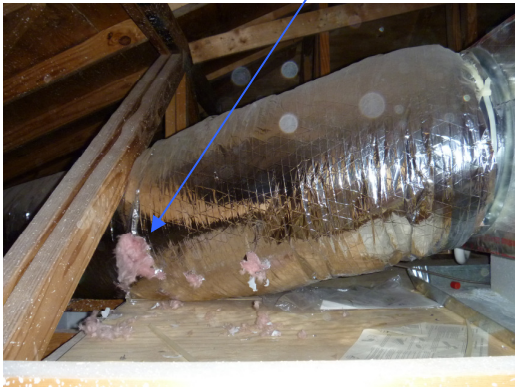
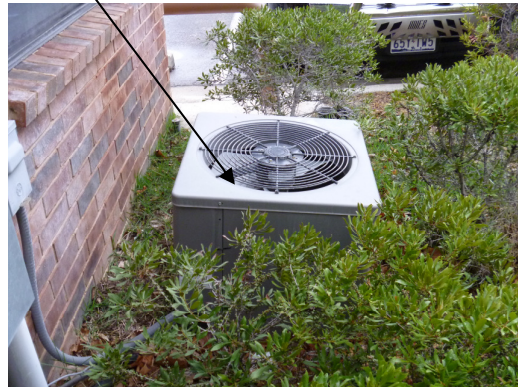
- Temps highlighted in red above for unit 201 & 202 are not within the recommended 15-22' drop range and may indicate a low level of freon or other cooling issues. Recommend having a complete checkout of all 4 units by licensed service company.
- All heating units exceeded 100°F in a reasonable time frame.
- Due to limited attic access thru ceiling panels, the blower/evaporator coils/drain pans/ducts were not inspected.
- A few ducts had damaged insulating wrap noted and thermostat control in unit 203 is defective.
- Condenser unit for unit 203 is leaning/sinking into mulch-needs leveling on support pad. Wiring on condensing unit 202 is exposed on top of grill.

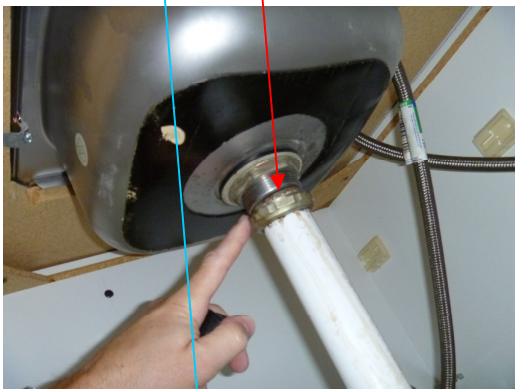
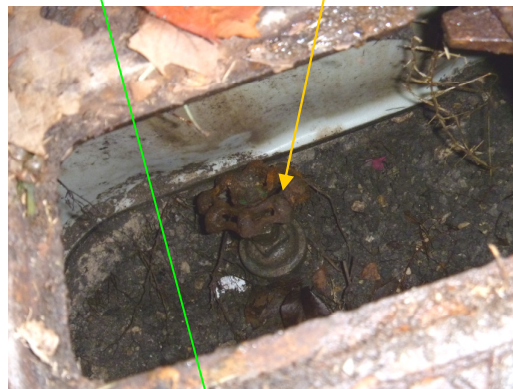
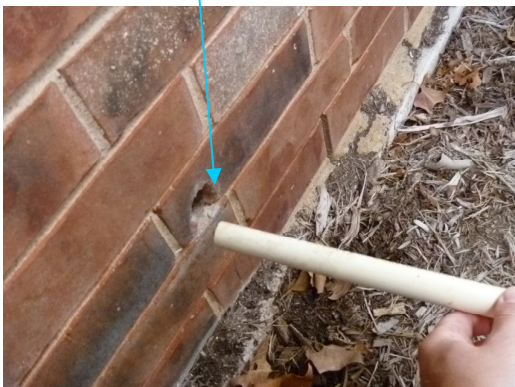
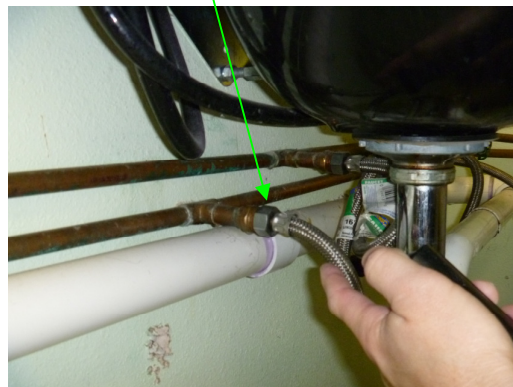
- Unit 200-Noted a clogged aerator on bathroom sink and missing aerator on kitchenette sink. Also need caulking around commode bowl floor joint.
- Unit 201-Water heater has signs of previous leak, kitchenette sink drain is loose/leaking at mounting flange and toilet tank lid is cracked.

- Unit 202/Salon-Left hair washing sink has signs of leaking at drain flange and separate supply line valve cutoffs were not present. Water heater is missing drain pan, wiring is laying on floor (not in protective conduit) and T,P&R valve drain is loose on exterior back wall.

- All Units-Bathroom sinks were loose on wall cleats and water heaters were missing drain pans, though heated water was noted at faucets for 200,201,202.

- Exterior-Hose bibs are missing backflow, anti-siphon prevention devices/vacuum breakers.
- Main meter and lines-Behind unit 202 one of the main shutoff valves appears to be damaged/possibly leaking. There was movement at main meter wheel with all valves shutoff. Recommend plumber checkout and repair any leaks as needed.

- Vents-only noted 2 wet vents on roof surface, unable to determine if this is adequate drainage per design.

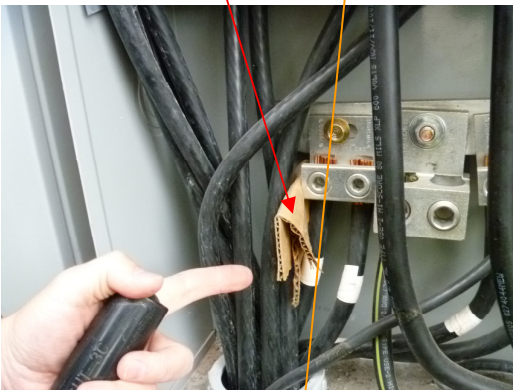
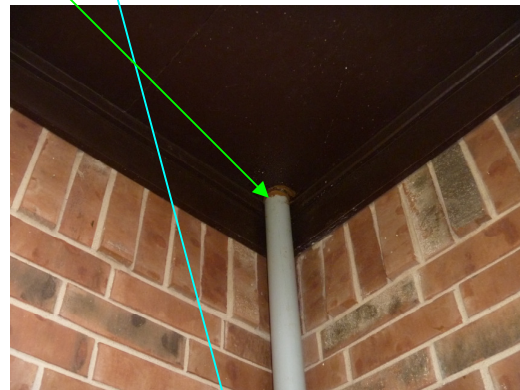
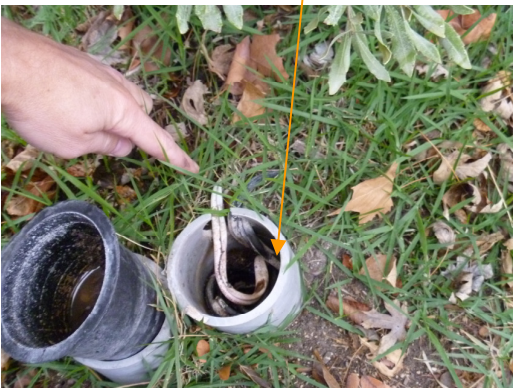
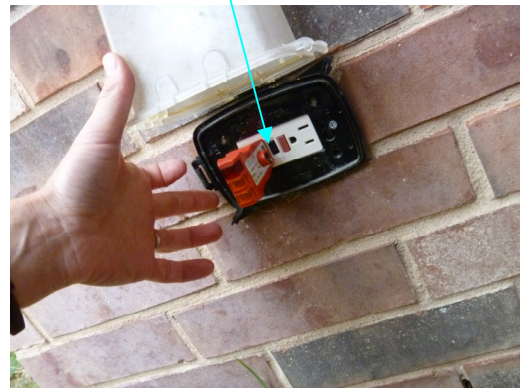
- All 4 subpanels-A/C circuits have 30amp breakers but unit tags call for 15amp max per manufacturer.
- Exterior GFCI outlet by electric meters is not working/button wont reset.
- Outlets in unit 202/salon near wet areas/wash stations are not GFCI protected.
- Main meters-conduit is loose at soffit corner entry and cardboard shim needs removal in raceway panel.
- Underground wiring is exposed at SE corner by electric meters.
- Recommend having an electrician repair items noted above as needed.
