## PROPERTY INSPECTION REPORT

**Prepared For:** John and Jane Doe  
(Name of Client)

**Concerning:** 1001 Towering Oaks, Austin, TX  
(Address or Other Identification of Inspected Property)

**By:** Justin Poague-TREC Lic#9076 12-9-14  
(Name and License Number of Inspector) (Date)

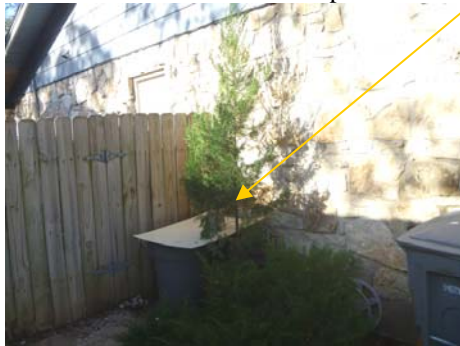
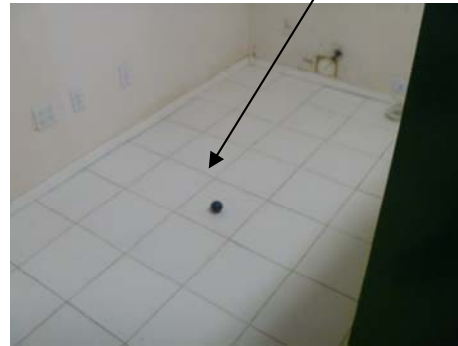
- x There does not appear to be any structural failure observed at this time and the foundation seems to be performing as intended. However, I did note floor slope in living rm, kitchen and laundry room areas and cracking across garage floor. This may be indicative of shifting and settling due to type of foundation, age, consolidation, soil and drainage characteristics. If this concerns you, I recommend having a structural engineer analyze foundation for further information.
- x Trees and/or large shrubbery are located too close to the foundation. This could have an adverse effect on future foundation performance, roof, gutters, etc.

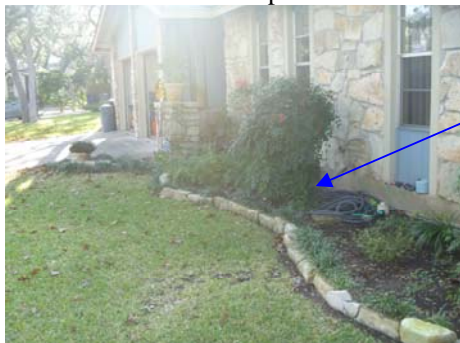
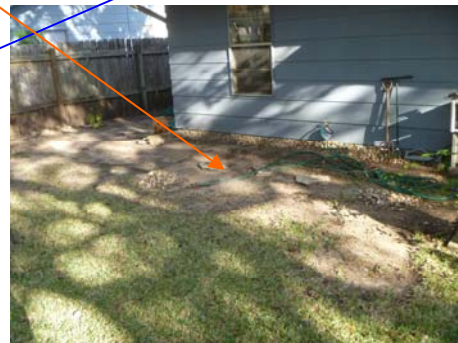
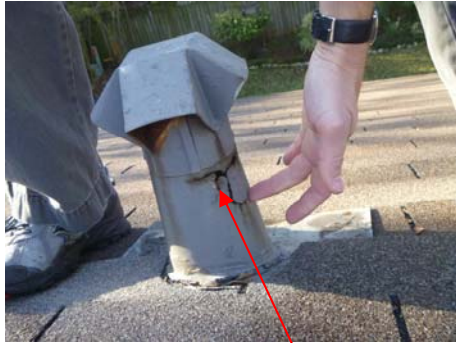
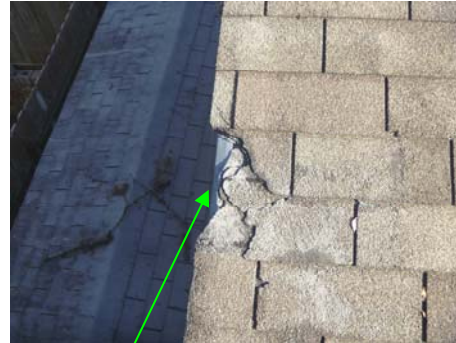
- x Gutters are pulling loose at backyard and are full of debris-need cleaning.
- x Storage bldg needs to be moved away from structure as it is allowing excess runoff to pond near slab.
- x Observed low area with potential for ponding at front right corner and flowerbed.
- x Drainage slope at back patio and right side of foundation is essentially flat or not well defined, with spots for water to pool.

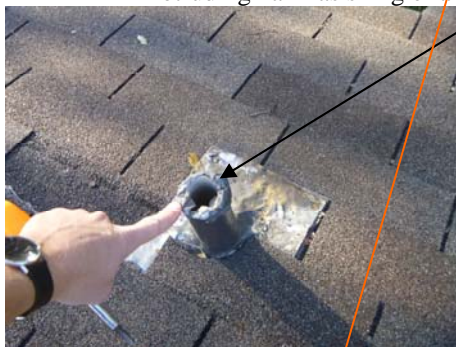
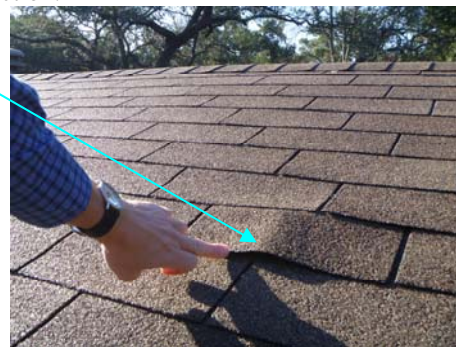
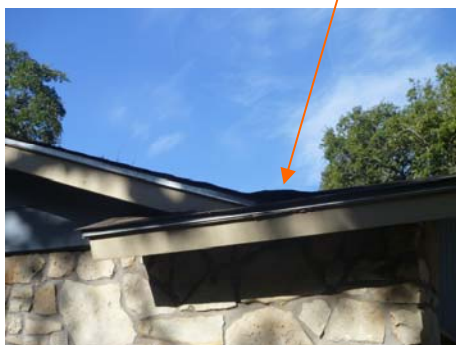
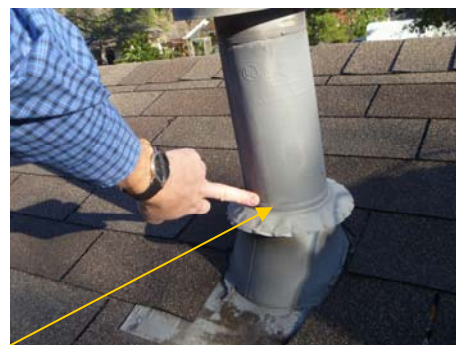
- x Observed damaged shingle(s) at section above storage bdlg.
- x Roof vent is damaged/rusted and may be allowing water penetration.
- x Exposed nail heads and/or staples at ridges and/or flashing areas need to be sealed with caulk.
- x Trees near the structure need to be trimmed at least 5' away from the roof.
- x Lead flashing on vent stack pipes are deteriorated and/or not properly curled over the top of the pipe.
- x Flashing is lifting and/or pulling loose at left side valley. Needs securing to prevent water penetration.
- x Protruding nail has shingle raised over front section.

- x Rain-collar on the exhaust vent flashing needs to be caulked with sealant at top seam.
- x Oversized wet vent needs mesh screen to prevent pest and debris entry.

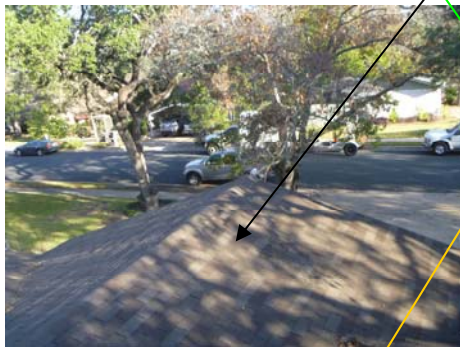
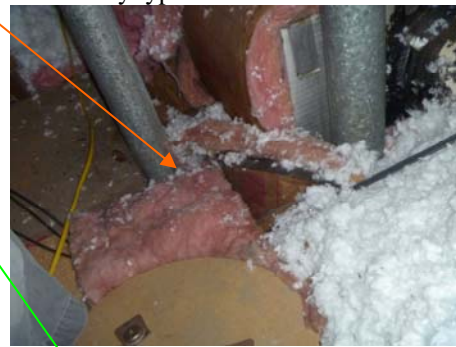
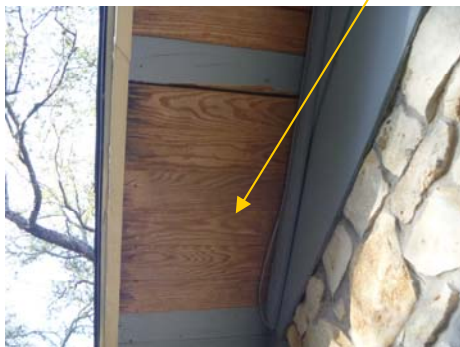
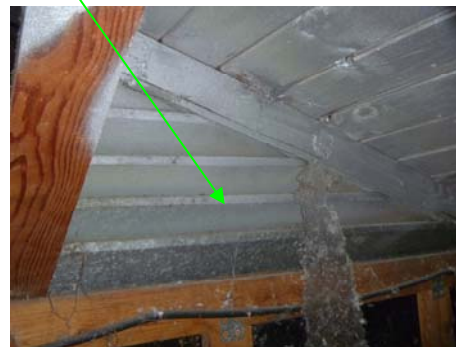
- x The attic has no high ventilation (turbines, static vents, ridge vents, power vents) over garage/porch gable.
- x Several sections of attic decking need painting to prevent weathering/moisture damage.
- x Limited number of soffit vents in place (should have 1 for every 150 ft. of ventilated space).
- x Soffit screen and gable screens are damaged at attic and back patio.
- x Attic insulation is in contact with water heater & furnace exhaust flue. There should be at least 2" clearance between metal exhaust flue and insulation of any type.

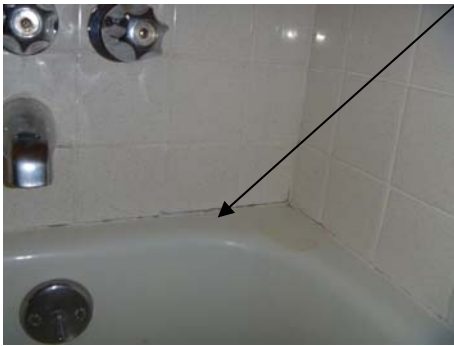
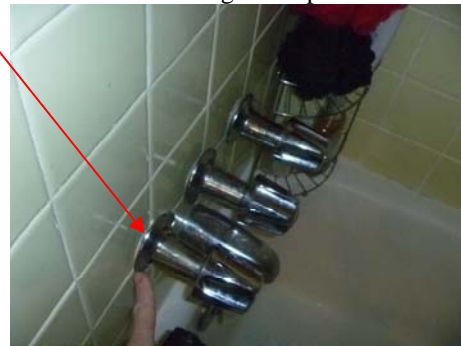
- x Bathrooms-Variou shower/tub wall joints need caulking (tiles, corners, etc).
- x Hall bath-tub control knob escutcheon covers are loose and allowing water penetration into wall.

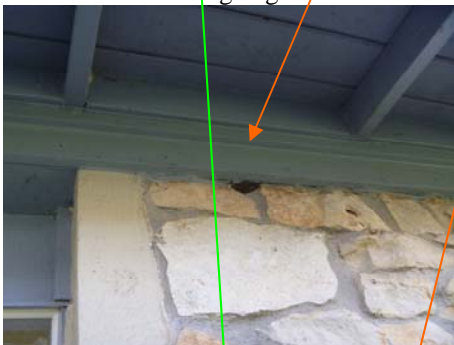
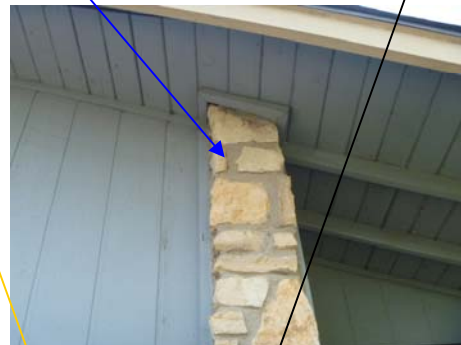
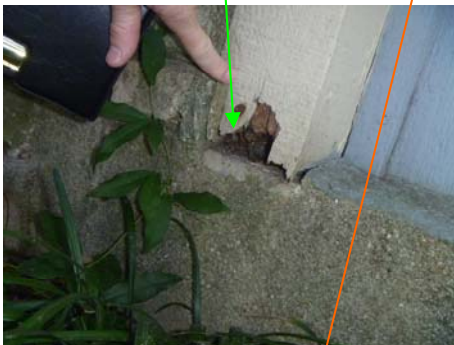
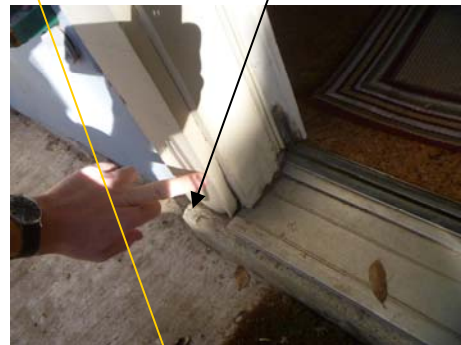
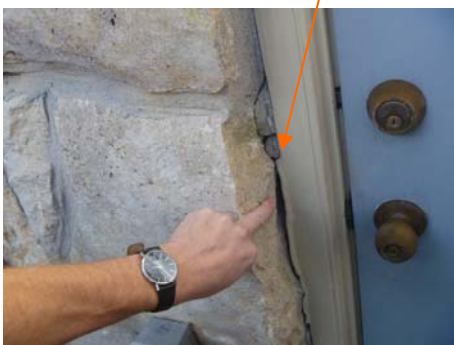
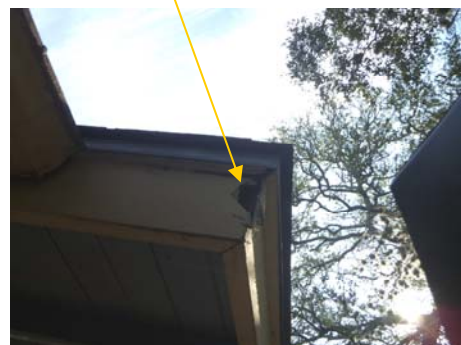
- x Open spots in stone openings and joints need sealing at various sections.
- x Observed previous repairs to exterior masonry at garage.
- x No masonry expansion joints noted at exterior walls (these help prevent stress cracking on the masonry).
- x No weep holes in place at bottom of exterior masonry.
- x Rot on trim noted at drip edge on left and back sides, at side door threshold, patio door trim, and at vertical trim on garage and front windows.

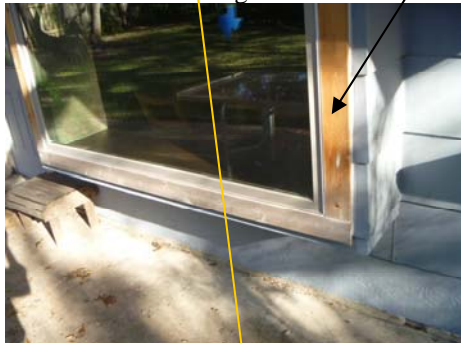
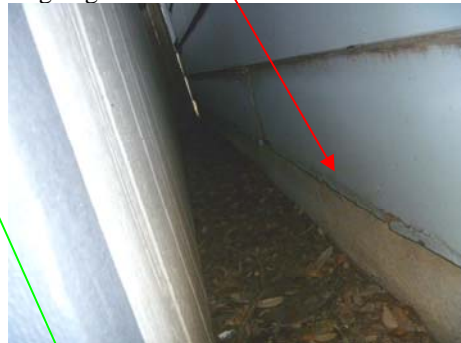
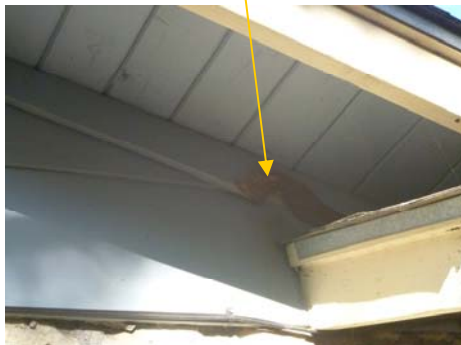
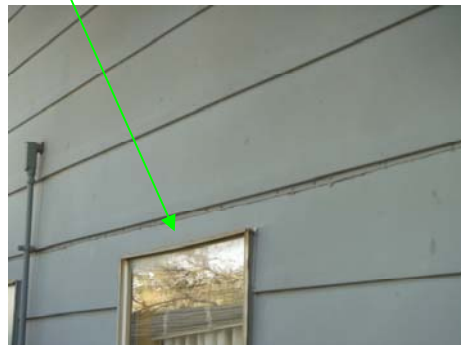
- x Signs of decay and previous termite infestation at right side wall by storage bldg.
- x Pest damage noted at fascia trim on left garage eave.
- x Paint is missing at trim around back windows.
- x Z-flashing was not installed over side windows or garage header trim.

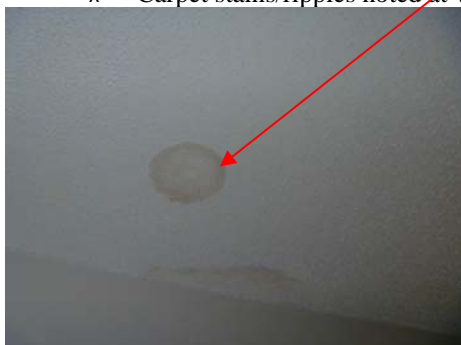
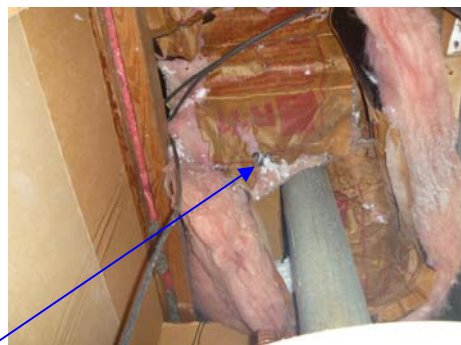
- x Observed patched/repaired areas on ceiling at garage.
- x Water stains noted on ceiling at foyer & living rm. Unable to determine if this is an active or ongoing leak.
- x Observed excessive slope on various floors.
- x Carpet stains/ripples noted at various rooms.

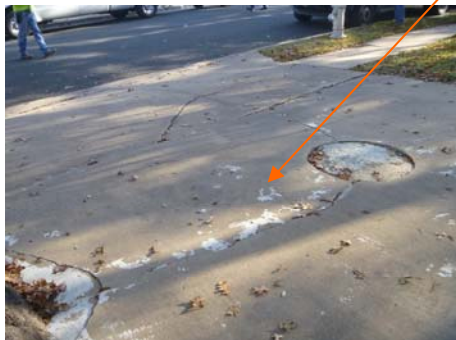
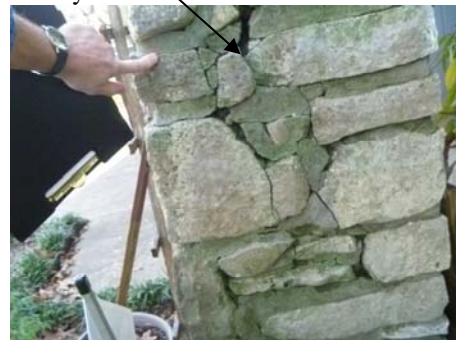
- x Noted some settling/cracking/deterioration of driveway slab.
- x Observed that the sidewalks have shifted/slipped away from home slab.

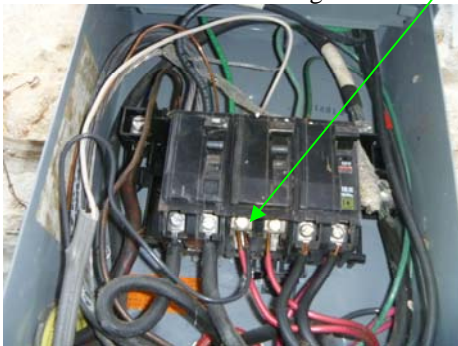
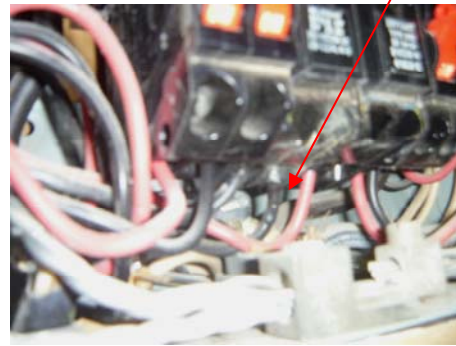
- x Recommend having the electrical panel checked by a qualified, licensed electrician.  
Main Panel
- x Oversized 40amp breaker noted on A/C circuit-tag calls for 30amp max.

- x The circuit locations are not fully marked/legible.
- x Observed doubled tapped breaker, (two wires under one breaker) in sub-panel. All branch circuit wiring should have its own circuit breaker.

- x No anti-oxidant gel observed on aluminum conductor terminations.  
Sub-Panel
- x Noted multiple neutral ground conductor wires under one termination screw.

- x Observed 220v dryer breaker is not tied together with a trip-tie. If the appliance experiences a situation which causes the breaker to trip, the trip-tie ensures that both 110v sides of the breaker trip together.

- x Scorched/damaged/deteriorated wiring insulation observed in the panel on dryer circuit.
- x No anti-oxidant gel observed on aluminum conductor terminations.

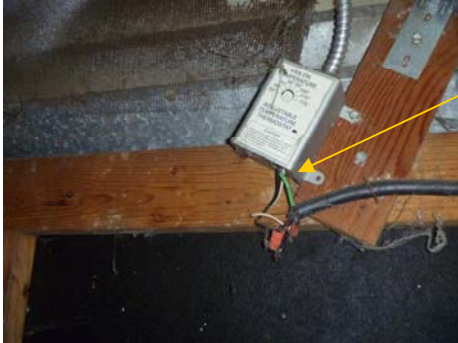
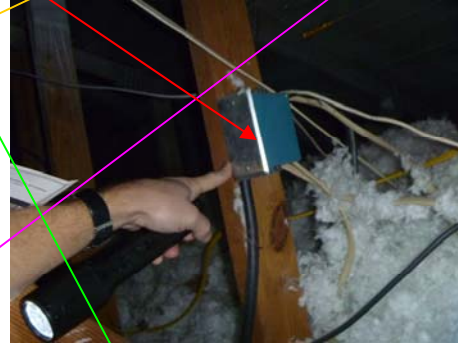
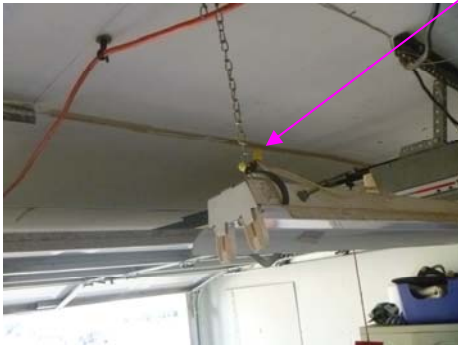
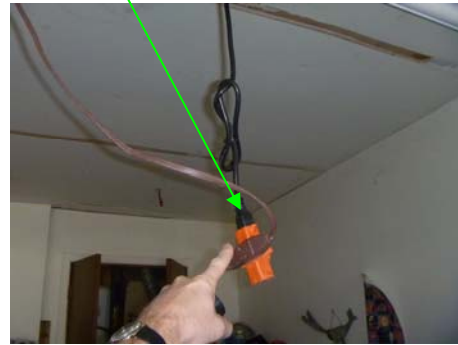
- x I recommend having the wiring further evaluated by a qualified, licensed electrician.
- x Smoke alarm missing from its bracket at master bedrm and is not installed at hall.
- x Kitchen counter outlets are not protected by Ground Fault Circuit Interrupters (GFCI's). Since 2000 all counter receptacles in the kitchen are required to be GFCI protected.
- x Garage and exterior outlets are not protected by Ground Fault Circuit Interrupters (GFCI's). Since 2008 all receptacles in the garage are required to be GFCI protected.
- x No Ground Fault Circuit Interrupter (GFCI's) outlets in place at laundry rm wall.
- x Electrical wiring out of the wall and not in protective conduit at disposer.
- x Tester shows outlet(s) not grounded at patio wall.
- x Some lights not responding/bulbs missing; replace bulbs and recheck fixtures.

- x Foyer switch is wired to operate interior and porch lights together.
- x Outlets have damaged/chipped prong face slots, etc at various locations.
- x No weatherproof cover in place on exterior outlet at back soffit eave and garage flood light is missing lens.
- x Observed wiring entering metal junction box with no clamps at attic.
- x Attic-junction boxes are undersized (cabling) and need to be replaced to code.
- x Wire cable spliced together but not in a protective junction box at attic gable fan and garage fixture.
- x Observed extension cords being used for permanent wiring at garage door opener.
- x A random inspection of outlets/switches revealed that the aluminum wiring has not been properly pigtailed with a copper jumper wire as current standards require.

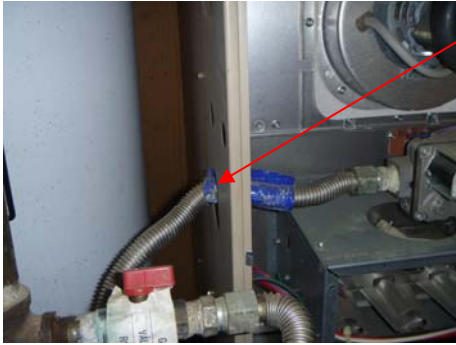
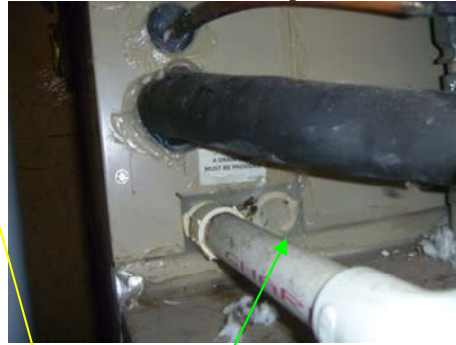
- x The furnace junction box inside the cabinet is missing its cover.
- x The heating unit appears to have insufficient combustion/draft air.
- x The heating unit vent pipe does not have the proper clearance from combustibles where it passes through the ceiling (1" for double-wall pipe and 6" for single-wall pipe).

- x The flexible line supplying gas to the furnace has no collar, grommet or other protective material in place where it enters the cabinet. It is possible for cabinet vibration to wear on the line and cause a leak.
- x Gas line for water heater and furnace needs to be secured to wall with straps.

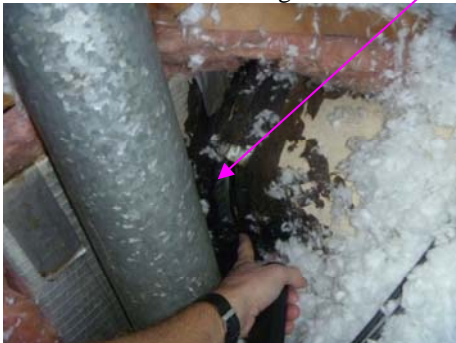
- x Recommend cooling unit be checked/serviced/repared by a qualified HVAC technician.
- x Recommend insulating the first 1' to 2' of drain line as it exits the evaporator coil housing; this prevents condensation sweat from forming on the pipe and dripping.
- x The air handler's secondary drain is missing the Safe-T float cutoff switch.
- x Condensing unit fins and inner base need to be cleaned of debris.

- x Air can be felt around opening at duct plenum seal in attic.
- x Large amount of debris seen in the return air plenum at HVAC closet-needs cleaning.
- x Registers/ducts were not installed at bathrooms.
- x Filter is wrong size and needs replacing.

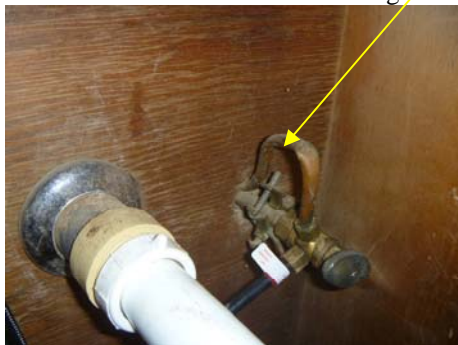
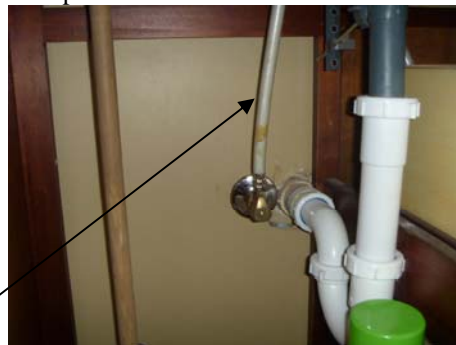
- x Recommend having the plumbing system checked/serviced/repared by a qualified, licensed plumber.  
Supply Plumbing
  - x Exterior bibbs/faucets are not equipped with backflow prevention devices that insure water flows out and cannot siphon back into the home.
  - x Homeowner shutoff valve for main water supply line was not found.
  - x There was a reading of 90psi static water pressure at the front hose faucet. Anything above 80psi can strain fixtures/fittings. A pressure reducing valve is required to bring the water pressure below 80psi.
- Kitchen
- x Cold water copper tap is kinked/bent.
  - x Hot and Cold valves are reversed at sink faucet.
  - x Faucet is not seated on gasket base at sink counter top.

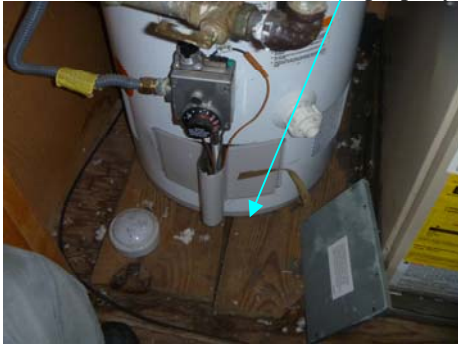
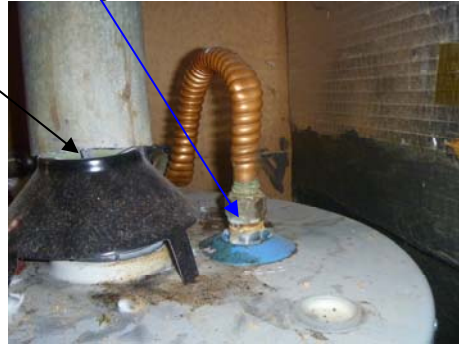
- x No manufacturer recommended drain pan installed under unit.
- x No insulation on water supply lines to a unit located in areas that could be subjected to freezing temperatures.

- x Water supply connections at the unit have some rust/corrosion.
- x The water heater is not raised 18" above the garage floor. Units located in spaces that are not part of the living area and that open into a garage should have ignition sources (gas or electric) elevated a minimum of 18" above the garage floor.

- x Water heater appears to have insufficient combustion/draft air. An opening is required within 12" of top and bottom of closet for proper ventilation.

- x No vent pipe firestop/support collar in place at the ceiling penetration.
- x The draft hood is not properly mounted/positioned on top of the water heater.

- ✓ Water heater(s) is operating and delivering hot water to all accessible faucets/fixtures at this time.
- Deficient Items: Water Heating Equipment**
- x Recommend having the water heater checked/repared by a qualified, licensed plumber.

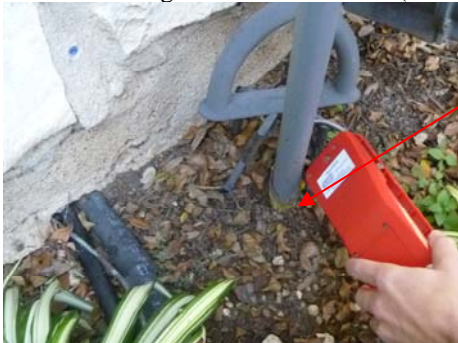
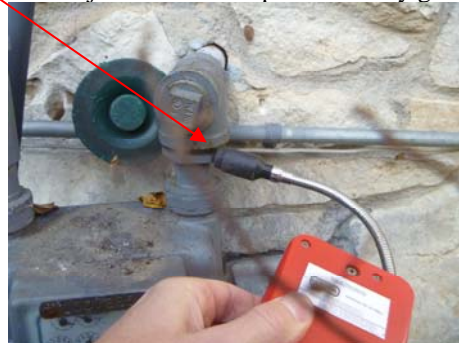
- x A gas leak was detected (with TIF 8800) at meter riser joints. Needs repair ASAP by gas company.

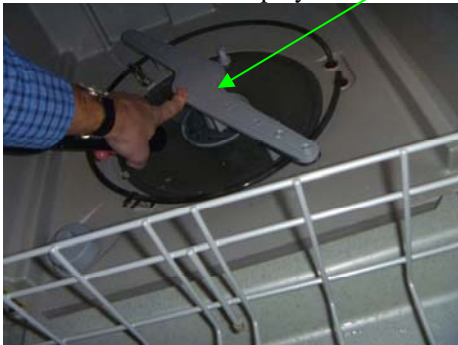
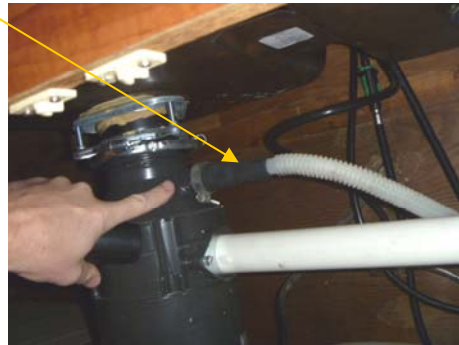
- x No backflow prevention device (drain line hose should be tied high in cabinet or air gap device installed) on drain line to disposer. Consult installation manual for further details.
- x The lower spray arm is loose.

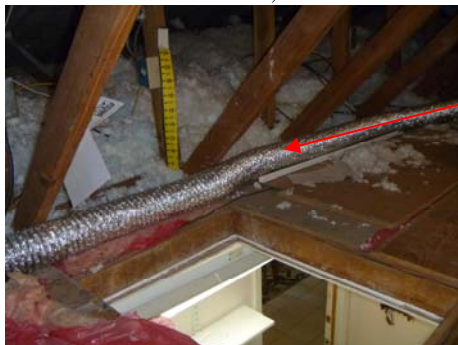
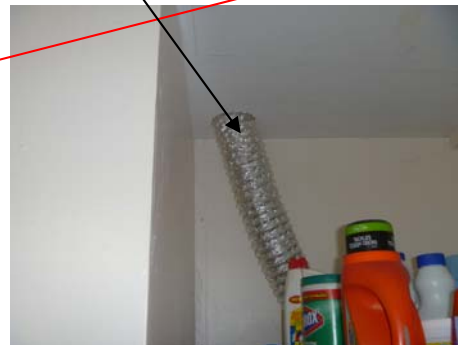
- F. Mechanical Exhaust Vents and Bathroom Heaters**  
*Type of Units:* Exhaust Fan/Electric Heater/  
*Comments:*  
**Deficient Items: Exhaust Fans, Vents & Bathroom Heaters**  
 x There is no exhaust fan at master bath.  
 x Hall exhaust fan is venting into the attic but current standards require fans to have vent ducting to exterior.

- G. Garage Door Operators**  
 Note: Remote transmitters & keypads are not inspected.  
*Comments:*  
**Deficient Items: Garage Door Openers**  
 x Manual lock noted on garage door(s) with an automatic opener. If lock is engaged and controls are operated, the door and head unit can be damaged. The manual lock should be removed or disabled.  
 x No optical eye (infrared) sensors on the right garage door.  
 x The left garage door opener's chain is loose/rubbing guide bar.

- H. Dryer Exhaust Systems**  
 Note: Laundry equipment limits the inspection of interior duct ports. Recommend cleaning out vent duct annually.  
*Comments:*  
**Deficient Items: Dryer Vents**  
 x Flexible metal transition duct being used for the dryer exhaust piping and the run is too long. It should be a smooth-wall, solid metal duct. Needs repair.
